TECHNICAL MEMORANDUM X-711

STRUCTURAL HEATING EXPERIENCES ON THE X-15 AIRPLANE* **

By Eldon E. Kordes, Robert D. Reed, and Alpha L. Dawdy

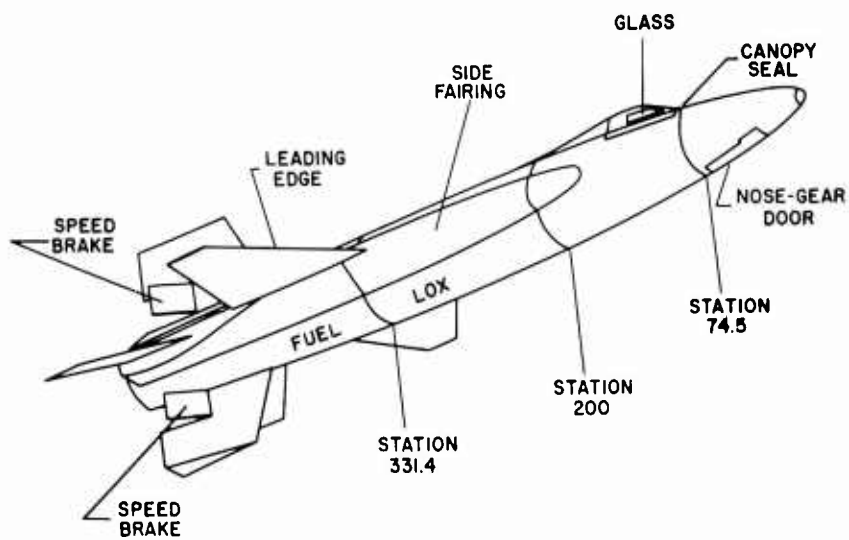
Figure 8

Some of the areas of the X-15 where structural problems have developed on the fuselage and wing as a result of heating or thermal stresses are shown in figure 8. They include the side fairings, nose-gear compartment, canopy seal, canopy glass, and wing leading edge.

THERMAL PROBLEM AREAS

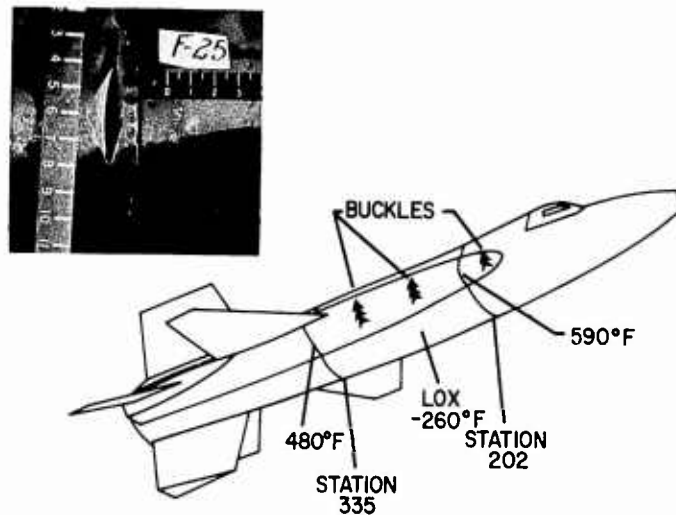
Figure 9

After the flight on March 7, 1961, in which a Mach number of 4.43 was reached, several permanent buckles were formed in the outer sheet of the fairing between the corrugations near the edge of a panel. Since these fairing panels are required to carry local air loads only, these buckles did not seriously affect the structural integrity. The maximum temperatures measured on the side fairing during this flight are shown in figure 9 for two fuselage stations in the area of the liquid-oxygen tank. The insert is a photograph of a typical buckle in the fairing panel. This buckle occurred near the wing leading edge on the left side of the airplane. The scales help show the extent of the buckle; the depth of the buckle is about 1/4 inch. At fuselage station 202, just forward of the tank, the temperature was 590° F on the lower fairing and at fuselage station 335, just behind the tank, the temperature was 480° F. No measurements were available on the tank. The temperatures shown occurred after engine shutdown, which, on this flight, left about 20 percent of the fuel still in the tanks. The cold tank, about -260° F for liquid oxygen, together with the high skin temperatures on the fairings resulted in large gradients, and hence the buckles. The important results found were that these thermal gradients between the liquid-oxygen tank and the fairings were actually higher than calculated for the original design. The design was based on complete fuel burnout before the maximum skin temperatures were encountered. As a result of this experience, four expansion joints were installed in the fairing forward of the wing to give a total expansion capacity of slightly over 1 inch. To date, this modification has prevented additional permanent buckles in the fairing for similar flights to higher temperatures.

MAXIMUM SIDE-FAIRING TEMPERATURES DURING FLIGHT TO MACH NUMBER OF 4.43

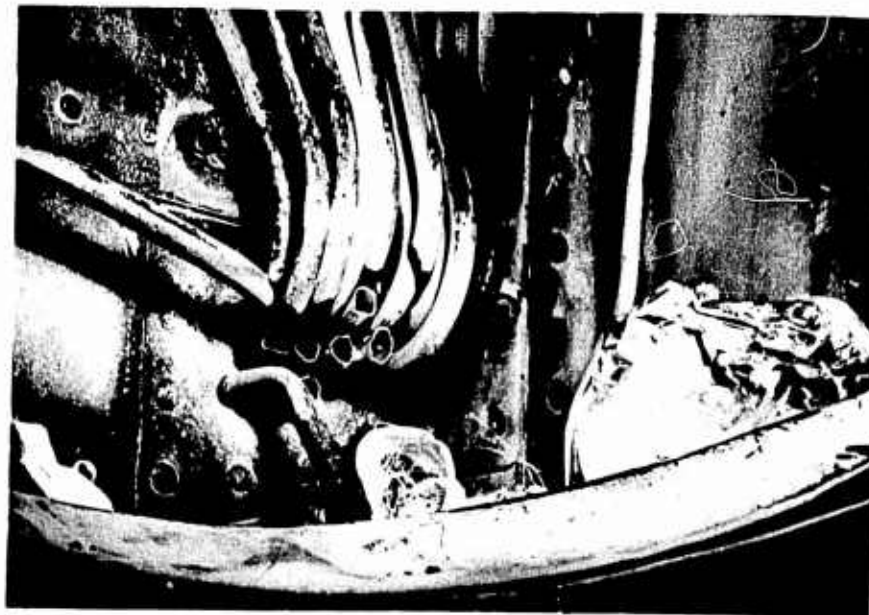
Figure 10

Damage from airflow into the structure.- Another heating problem that has developed on the X-15 is caused by airflow into the interior of the structure. This flow has resulted in unexpected high temperatures around the speed-brake actuators, and loss of instrumentation wires at the roots of the wing and tail surfaces. On the forward fuselage, the seal of the canopy has been damaged because of a slight raising of the front edge by cabin pressure, which allowed hot air to flow against the seal. This problem has been solved by attaching a shingle-type strip to the fuselage just ahead of the canopy joint to prevent airflow under the edge of the canopy. A similar problem has developed in the nose-gear compartment. The small gap at the rear end of the nose-gear door was sufficiently large to allow the airstream to enter the compartment and strike the bulkhead between the nose-gear compartment and the cockpit. This stream caused a local hot spot. Aluminum tubing, for the pressure-measuring system, is attached to this bulkhead in the nose-gear compartment, and during a flight to a Mach number of 5.2, portions of the tubing melted away. A photograph of this damage is shown in figure 10. Pictured are the aluminum tubing with the damaged area and the titanium bulkhead between the nose gear and pilot compartment. The bulkhead was heated to about 530° F, which was sufficiently high to scorch the paint on the bulkhead in the pilot's compartment and cause smoke in the cockpit. Since this flight, an Inconel compression seal has been added to the rear end of the nose-gear door and additional protection has been provided by placing a baffle plate across the compartment just behind the door opening.

HEAT DAMAGE TO ALUMINUM TUBING

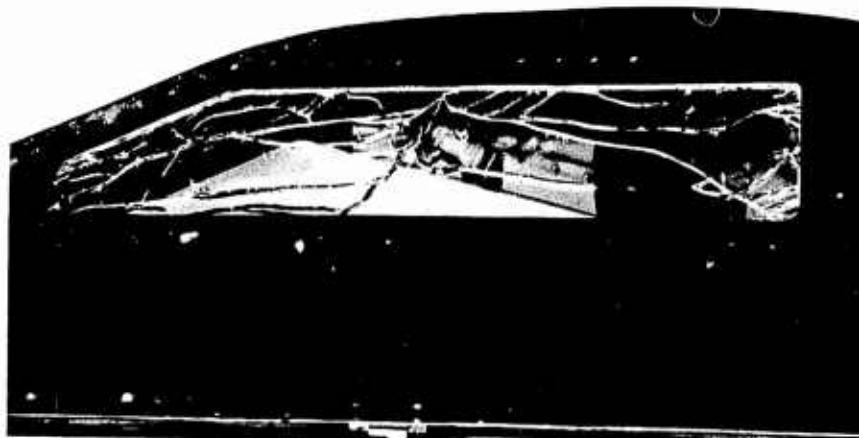
Glass failure.- The windshield glass originally installed on the X-15 was soda-lime tempered plate glass. This choice was based on a predicted maximum temperature of 740° F. Data obtained on early flights indicated that outer-face temperatures near 1,000° F could be expected with a differential temperature between faces of 750° F. It was apparent that soda-lime glass would not withstand these temperatures and that alumino-silicate glass should be a satisfactory replacement. The alumino-silicate glass has higher strength and better thermal properties which reduce the expected temperature and gradients to about 70 percent of those predicted for soda-lime glass. The alumino-silicate glass withstood thermal tests to temperatures which were about 1.5 times greater than the expected flight values. Subsequently, the alumino-silicate glass was installed in all three X-15 airplanes; however, one of the soda-lime windshields was inadvertently installed at a later date, and it fractured during recovery from an altitude flight to

217,000 feet. On a speed flight to a Mach number of 6.04, one of the alumino-silicate glass panels also fractured. In both cases the glass fragments remained in place during the remainder of the flight. Photographs of the fractured panels are shown in figures 11 and 12. Figure 11 shows the soda-lime glass and figure 12 the alumino-silicate glass. The fracture pattern in figure 11 is not typical of tempered glass, but the pattern in figure 12 is typical. In both cases, the retainer frame buckled near the center of the upper edge of the glass and created a local hot spot at this point. Failure of both glass panels started adjacent to this buckle. Subsequent to the last failure, the retainer was changed from 0.050-inch-thick Inconel X to titanium that is 0.10 inch thick in order to eliminate buckling and, hence, the local hot spot.

DAMAGED WINDSHIELD GLASS FOLLOWING
FLIGHT TO 217,000 FEET ALTITUDE

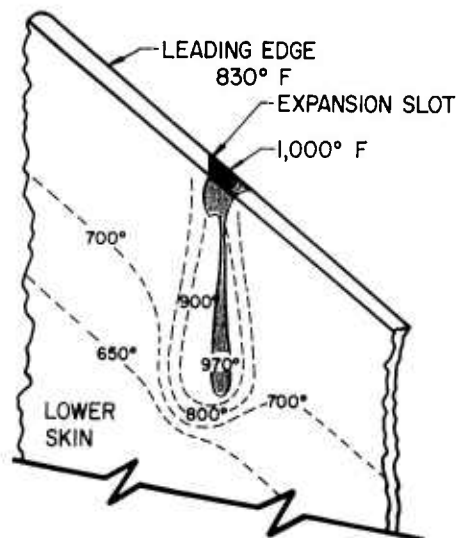
Figure 14

The temperature distributions in the vicinity of these slots, on a flight to a Mach number of 5.3, are shown in figure 14. These data were obtained from the paint pattern since no thermocouples were located in this region; however, the paint colors obtained were correlated with thermocouple data at other points on the wing. This figure shows a segment of the wing leading edge, the expansion joint, and a section of the lower skin. The expansion joints are slots about 0.080-inch-wide cut in the heat sink. The average leading-edge temperature was 830° F and just outboard of the slot on the leading edge is a small area with temperatures above 1,000° F. An area between 970° F and 1,000° F extends rearward on the skin about 8 inches, and the average skin temperature away from the slot is below 800° F.

TEMPERATURE DISTRIBUTION AFT OF LEADING-EDGE EXPANSION SLOT

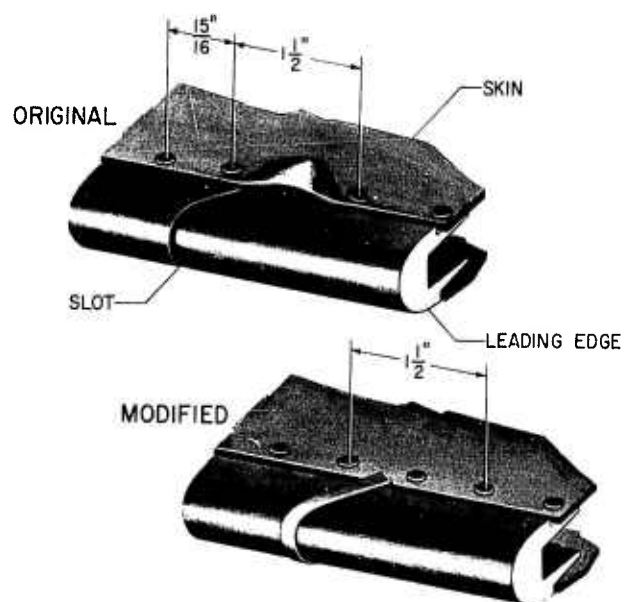
Figure 15

On this flight, permanent interrivet buckles were formed directly behind the three outboard slots of the leading edge. The type of buckle

and the location are illustrated by the upper sketch in figure 15. This sketch shows a portion of the leading-edge heat sink, the expansion slot, the external skin with the buckle, and the fastener location. Note that the fastener spacing directly behind the slot is wider than the spacing along the solid portion of the leading edge. Subsequent analysis of the leading-edge structure has indicated that several factors contributed to the permanent buckling of the skin. One factor is the thermal stresses in the skin caused by the high gradients around the local hot spot. Another factor is the wide fastener spacing through the leading edge at the slot. A third reason for the buckles is the fact that the original segmentation of the leading-edge heat sink did not adequately relieve the thermal-induced compression loads. The skins at the slots acted as a splice plate for the heat-sink bar and thus were buckled in compression.

WING SKIN BUCKLE FOLLOWING FLIGHT
FLIGHT TO MACH NUMBER OF 5.28

In order to minimize this buckling problem, three design changes have been made. Two of the changes are shown in the lower sketch. An 0.008-inch-thick Inconel tab welded along one edge was installed over each slot to prevent tripping the boundary layer, and thus to minimize the local hot spots, as explained in reference 1. A fastener was added at the slot to decrease the fastener spacing and to increase the allowable skin buckling stress. In order to reduce the load that the skin splice must carry at each slot, the third change was to add expansion slots with cover tabs in three of the outboard segments of the leading edge.

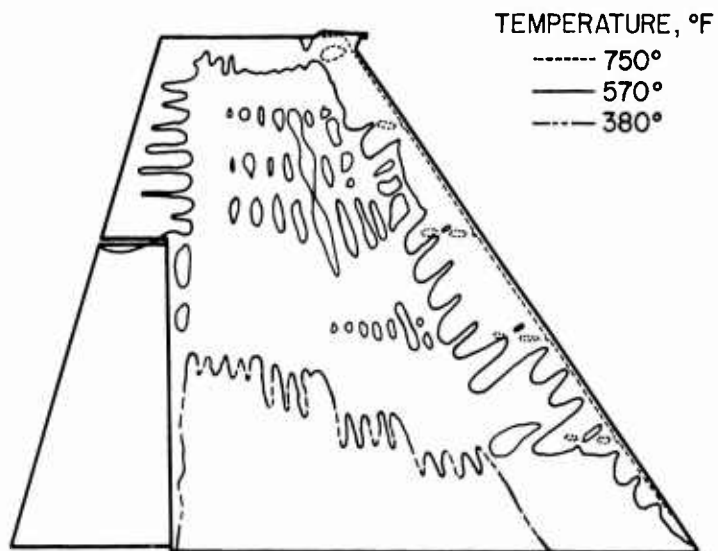
Figure 17

Overall temperature on the wing upper surface obtained during the speed flight to a Mach number of 5.30 is shown by the isotherms in figure 17. These isotherms were obtained from the color patterns of the temperature-sensitive paint. The term "isotherm" is used in a broad sense, since all color changes do not occur at exactly the same time.

It can be seen that the region near the wing root is less than 380° F and along the leading edge several regions are above 750° F. Small areas of high temperature directly behind the expansion joints are still present, even with the cover tabs, but the affected area is much smaller and does not extend forward to the leading edge. Similar applications of the temperature-sensitive paint have been used on other areas of the X-15 to obtain qualitative measurements of the temperatures. These areas include the cockpit canopy, horizontal and vertical tails, speed brakes, fuselage nose area, and protuberances such as probes, antennas, and vent lines.

WING ISOTHERMS FOLLOWING FLIGHT TO MACH NUMBER OF 5.30
